FACILITY COMPLIANCE AUDIT REPORT

Division of Waste Management Solid Waste Section

Date of Audit: January 31, 2011

Hertford County Transfer Station
227 Mount Moriah Road
Winton, NC 27986

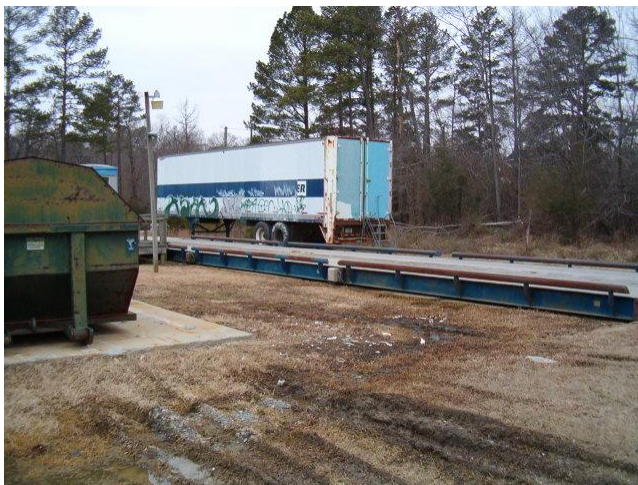
17. The tire certifications were checked and appear to be in order. Make sure that the tire haulers number or merchant number is included on the form in the second section. The scrap tires are laced in the enclosed tire trailer.

Trailer for tires.

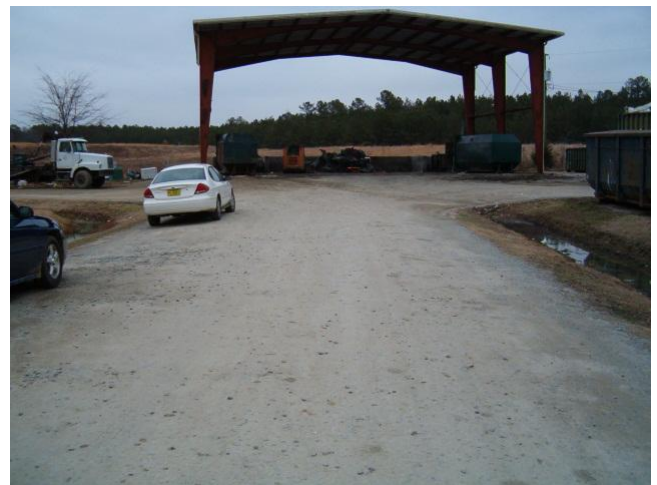
5. The waste is being transferred to East Carolina Environmental in Bertie County.
6. The service area for this facility is Hertford County.
7. The bulky furniture, mattresses, C&D, etc. are put in an open top 40 yard container and the other debris is put into one of the two compactors on either side of the tipping floor.

Transfer facility with compactors on both sides.

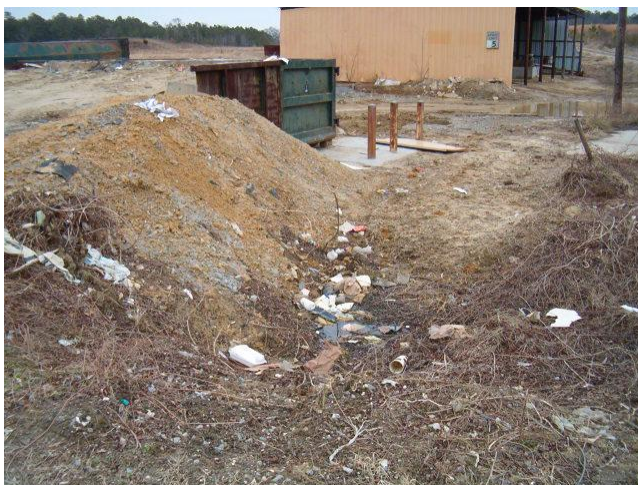
11. The windblown litter is being managed well. There was some debris near the newly built ramp, which needed to be picked up.
12. Certified Transfer Station Operator: Donnell Cooper, expires 11-16-13
Gilbert W. Stephen, expires 12-5-11
Clifton Boyd, expires 12-5-11

Waste on ground that needs to be picked up.

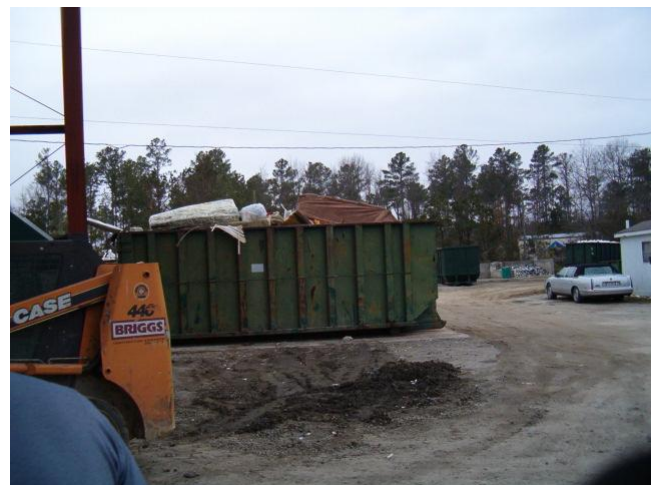
Container for bulky items.

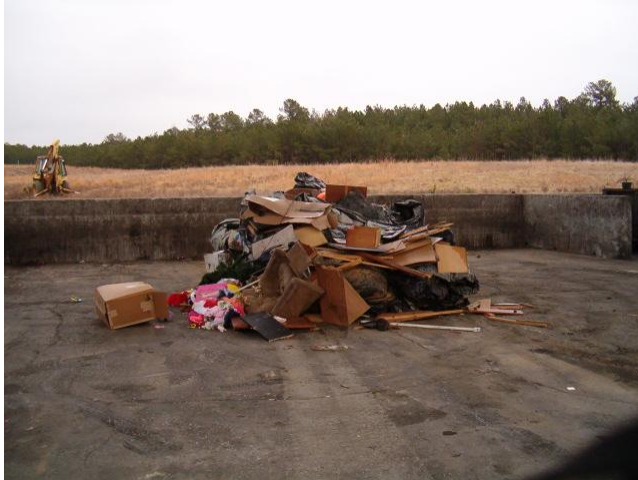
10. The tipping floor does have cracks. The cracks do not appear to be deep enough to allow the seepage of leachate to the soil underneath. The tipping floor is going to need repair, but until then it should be insured that the floor can be kept in a sanitary condition.

Waste just brought in to tipping pad.

9. The tipping floor and compactors were fairly clean; however, cleaning with a pressure washer on a regular basis would provide better results, especially under the compactors. Melvin Nichols stated that the tipping floor is swept every night. At the time of this inspection the tipping floor did not appear to be wet at all. According to the approved Operations Plan, *"water that contacts waste must be collected and properly treated prior to discharge. The only area where water can come into contact with waste is the tipping floor. Contact with rain water is reduced due to the covering. However, if any waste blows under the roof and onto the tipping floor, it is collected with a 55-gallon vacuum and stored in a 250-gallon capacity tank. When the tank is pumped out, the water is taken to the Ahoskie waste water treatment plant which is about 12 miles away for proper treatment."*

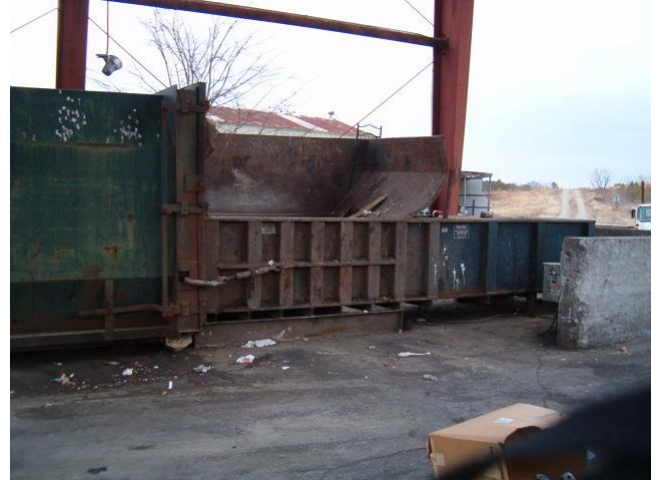
Compactor on the left side of the tipping pad.

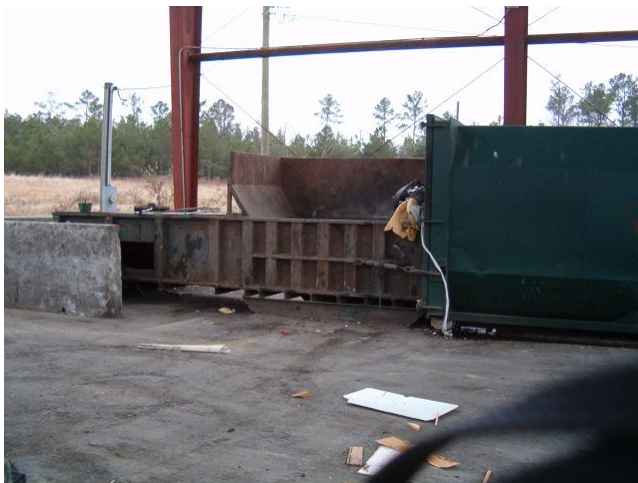
Compactor on the right side of the tipping pad.

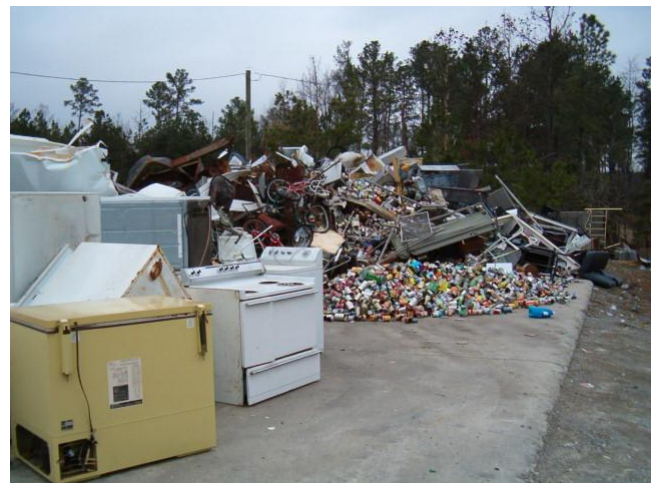
16. The white goods appear to be handled properly. The CFC's are removed by Liverman's Metal Recycling in Bertie County. The records of units and volume of CFCs removed is given to the County. It is recommended that the number of units with broken lines be included in the record keeping.

White goods and other metals area.

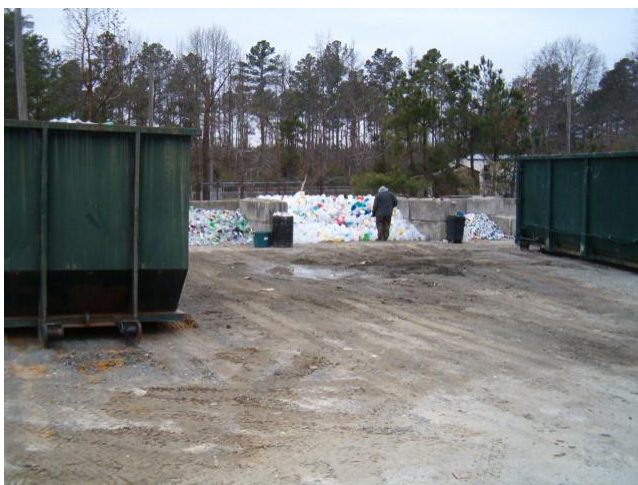
15. White goods, tires, batteries, propane tanks, pallets, pesticide containers, glass, and separated plastics are handled at the adjacent convenience site.

Recyclables at the adjacent convenience site.
